U.S.S. MONITOR

A FINAL REPORT
ON 1979 SITE TESTING IN THE MONITOR NATIONAL MARINE SANCTUARY

BY GORDON P. WATTS, JR.
NORTH CAROLINA DEPARTMENT OF CULTURAL RESOURCES

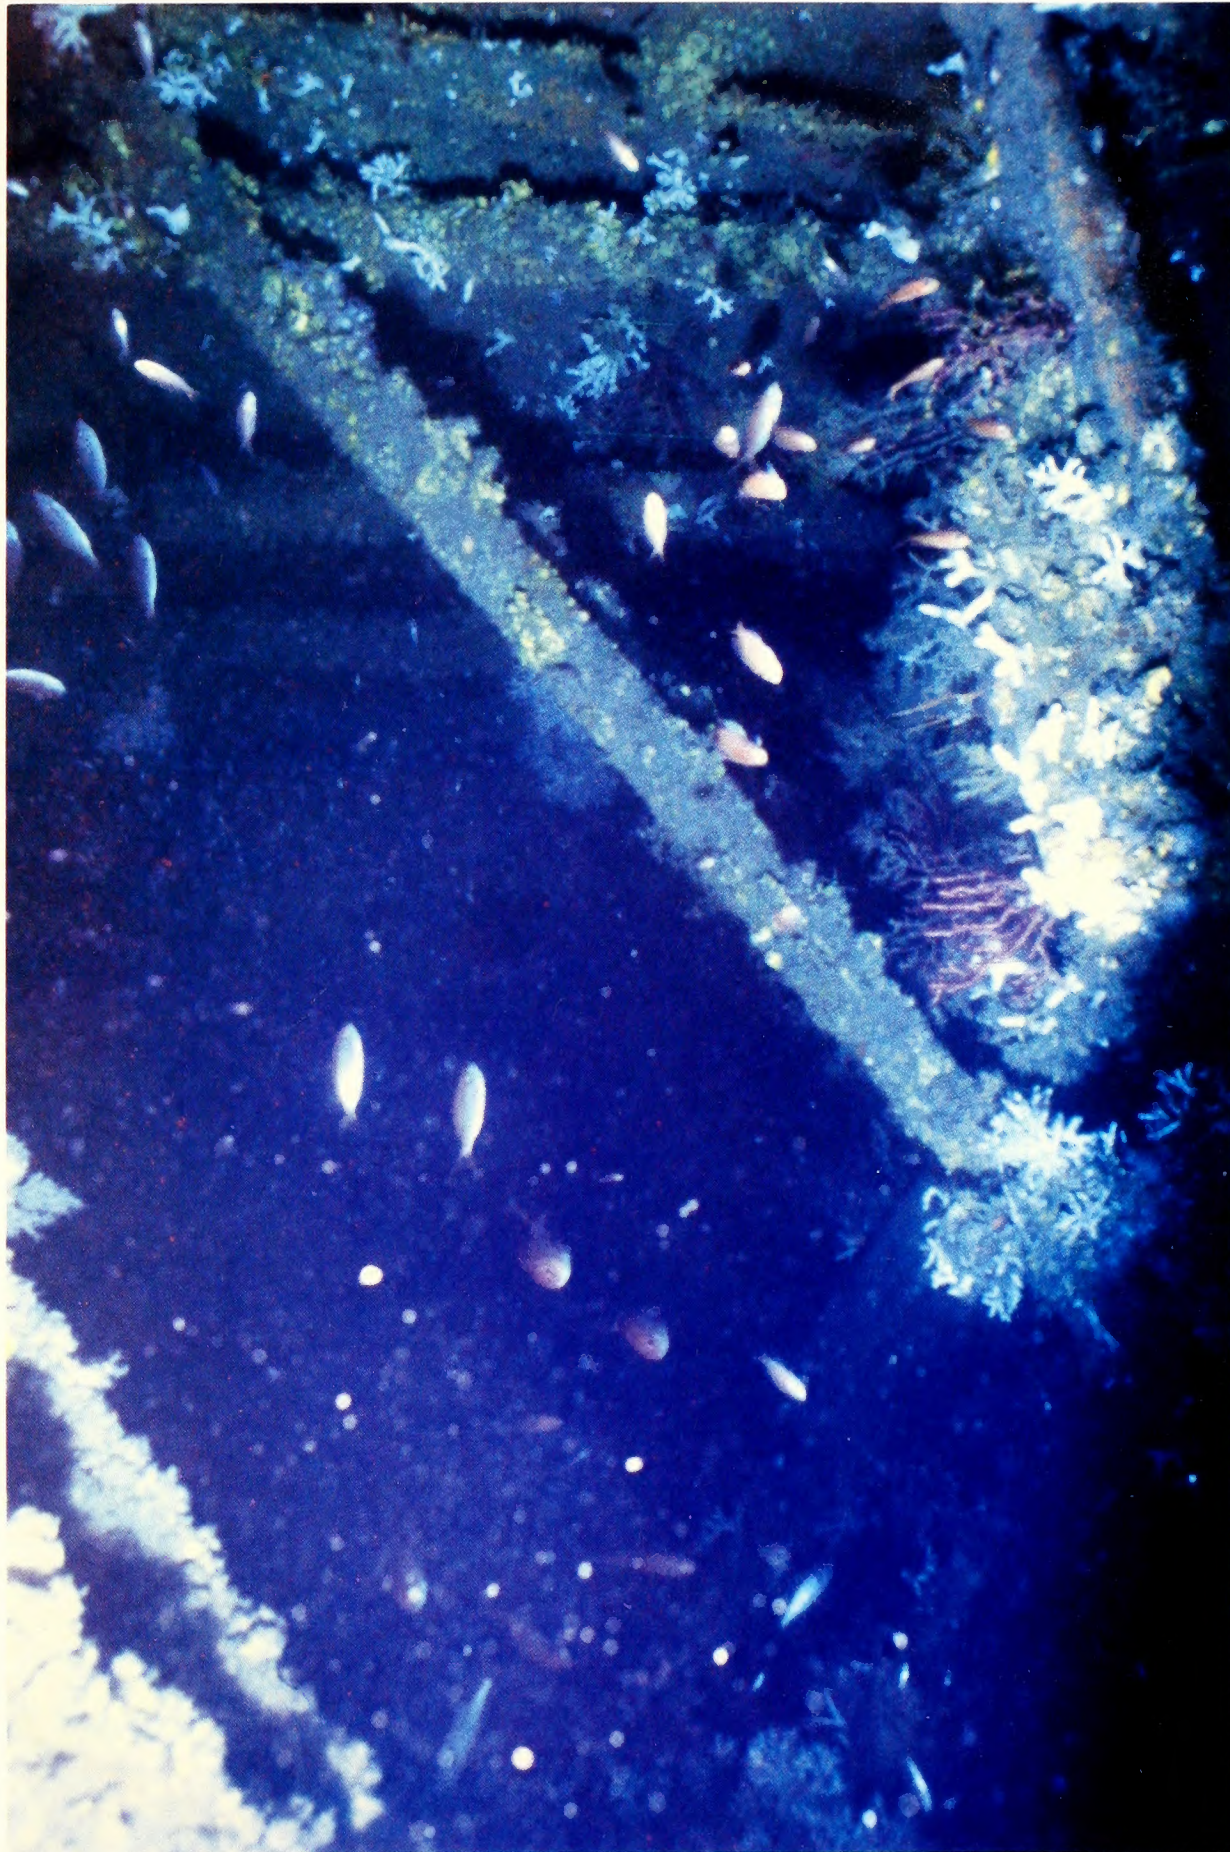
Figure 122. Coal bunker bulkheads, originally located to the left of the row of stanchions adjacent to the port boiler, have collapsed onto the deck beams. Looking aft between the port boiler and the port armor belt, the deck is covered with coal and debris from the deteriorated side of the lower hull.

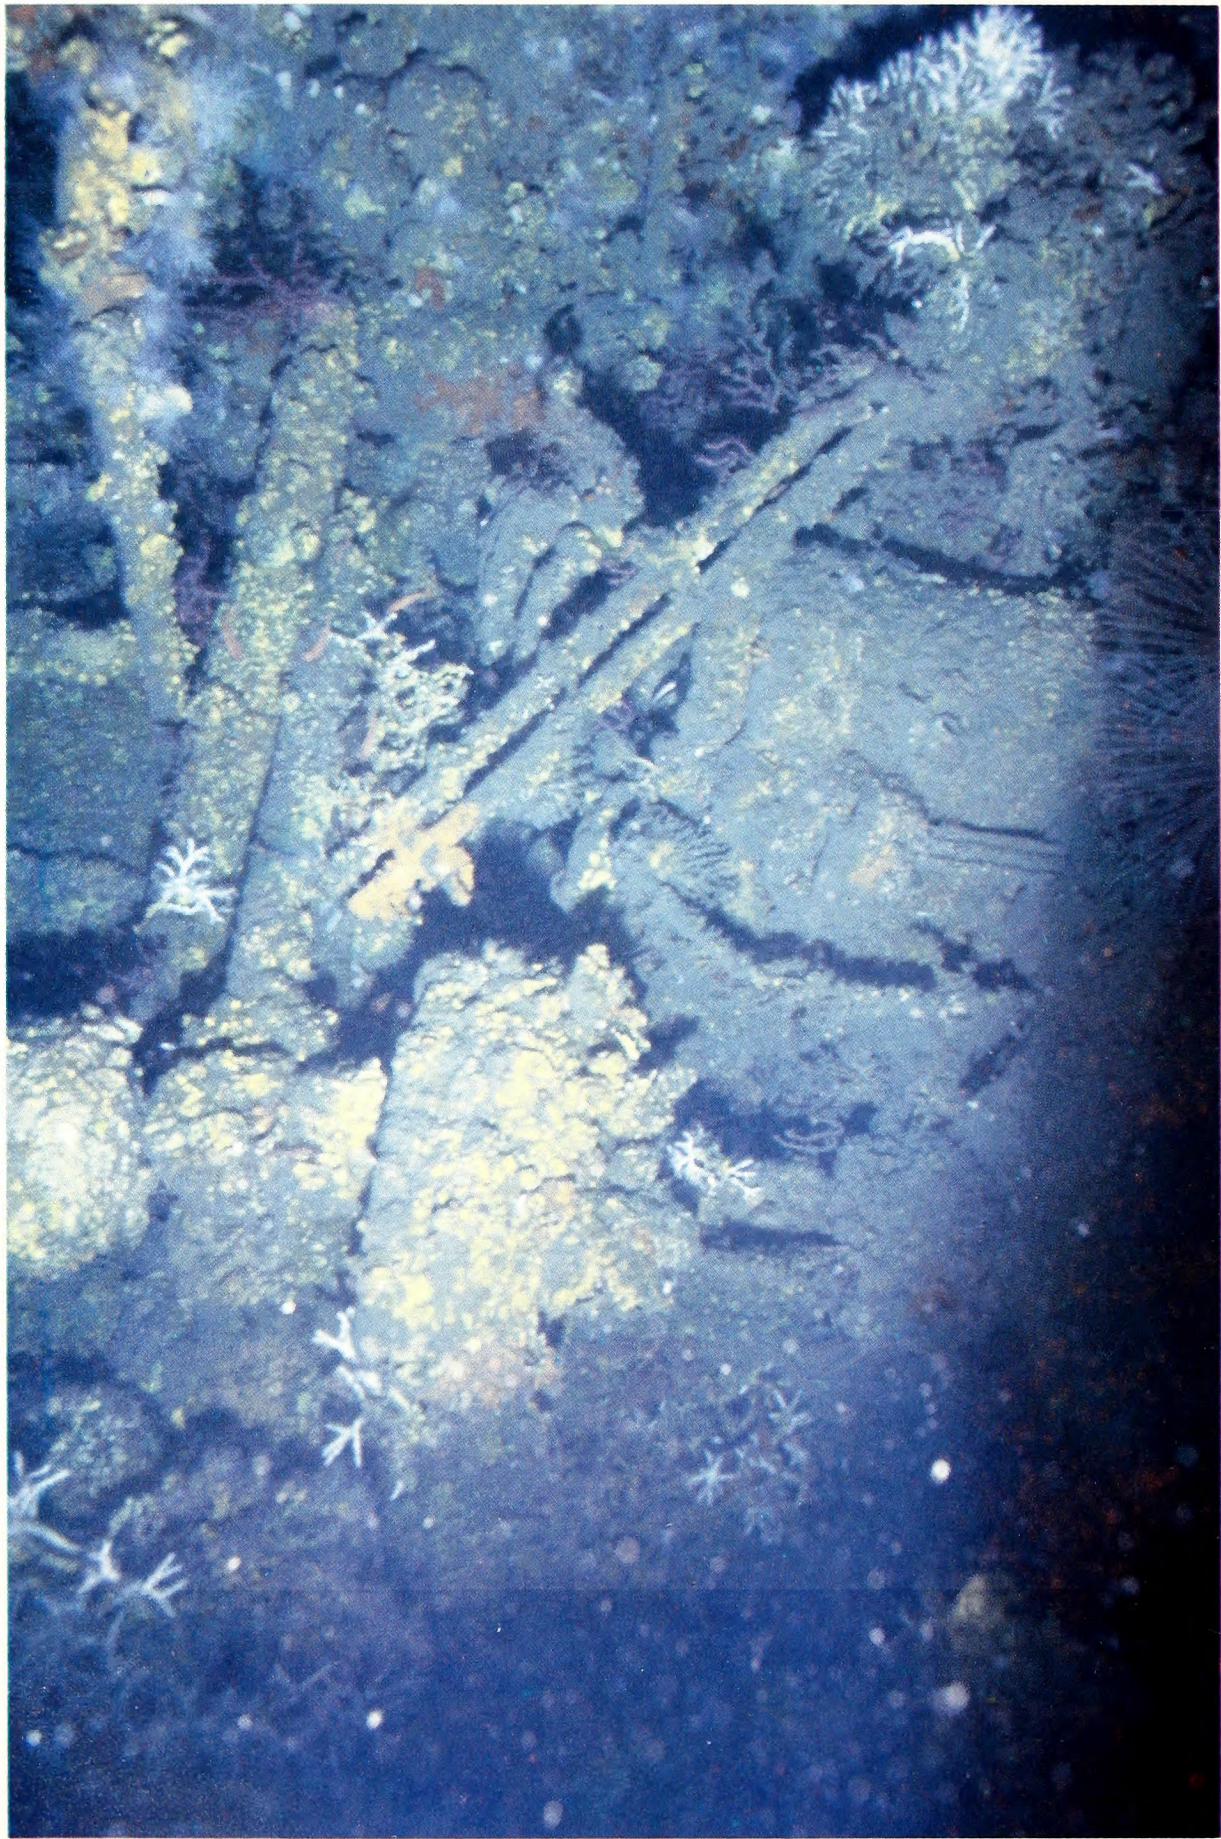
Figure 123. Although heavily coated by corrosion products and marine fouling organisms, the Monitor's steam machinery remains intact inside the lower hull. A glass tube water gauge protruding from the sediment at bottom center illustrates the excellent degree of preservation.

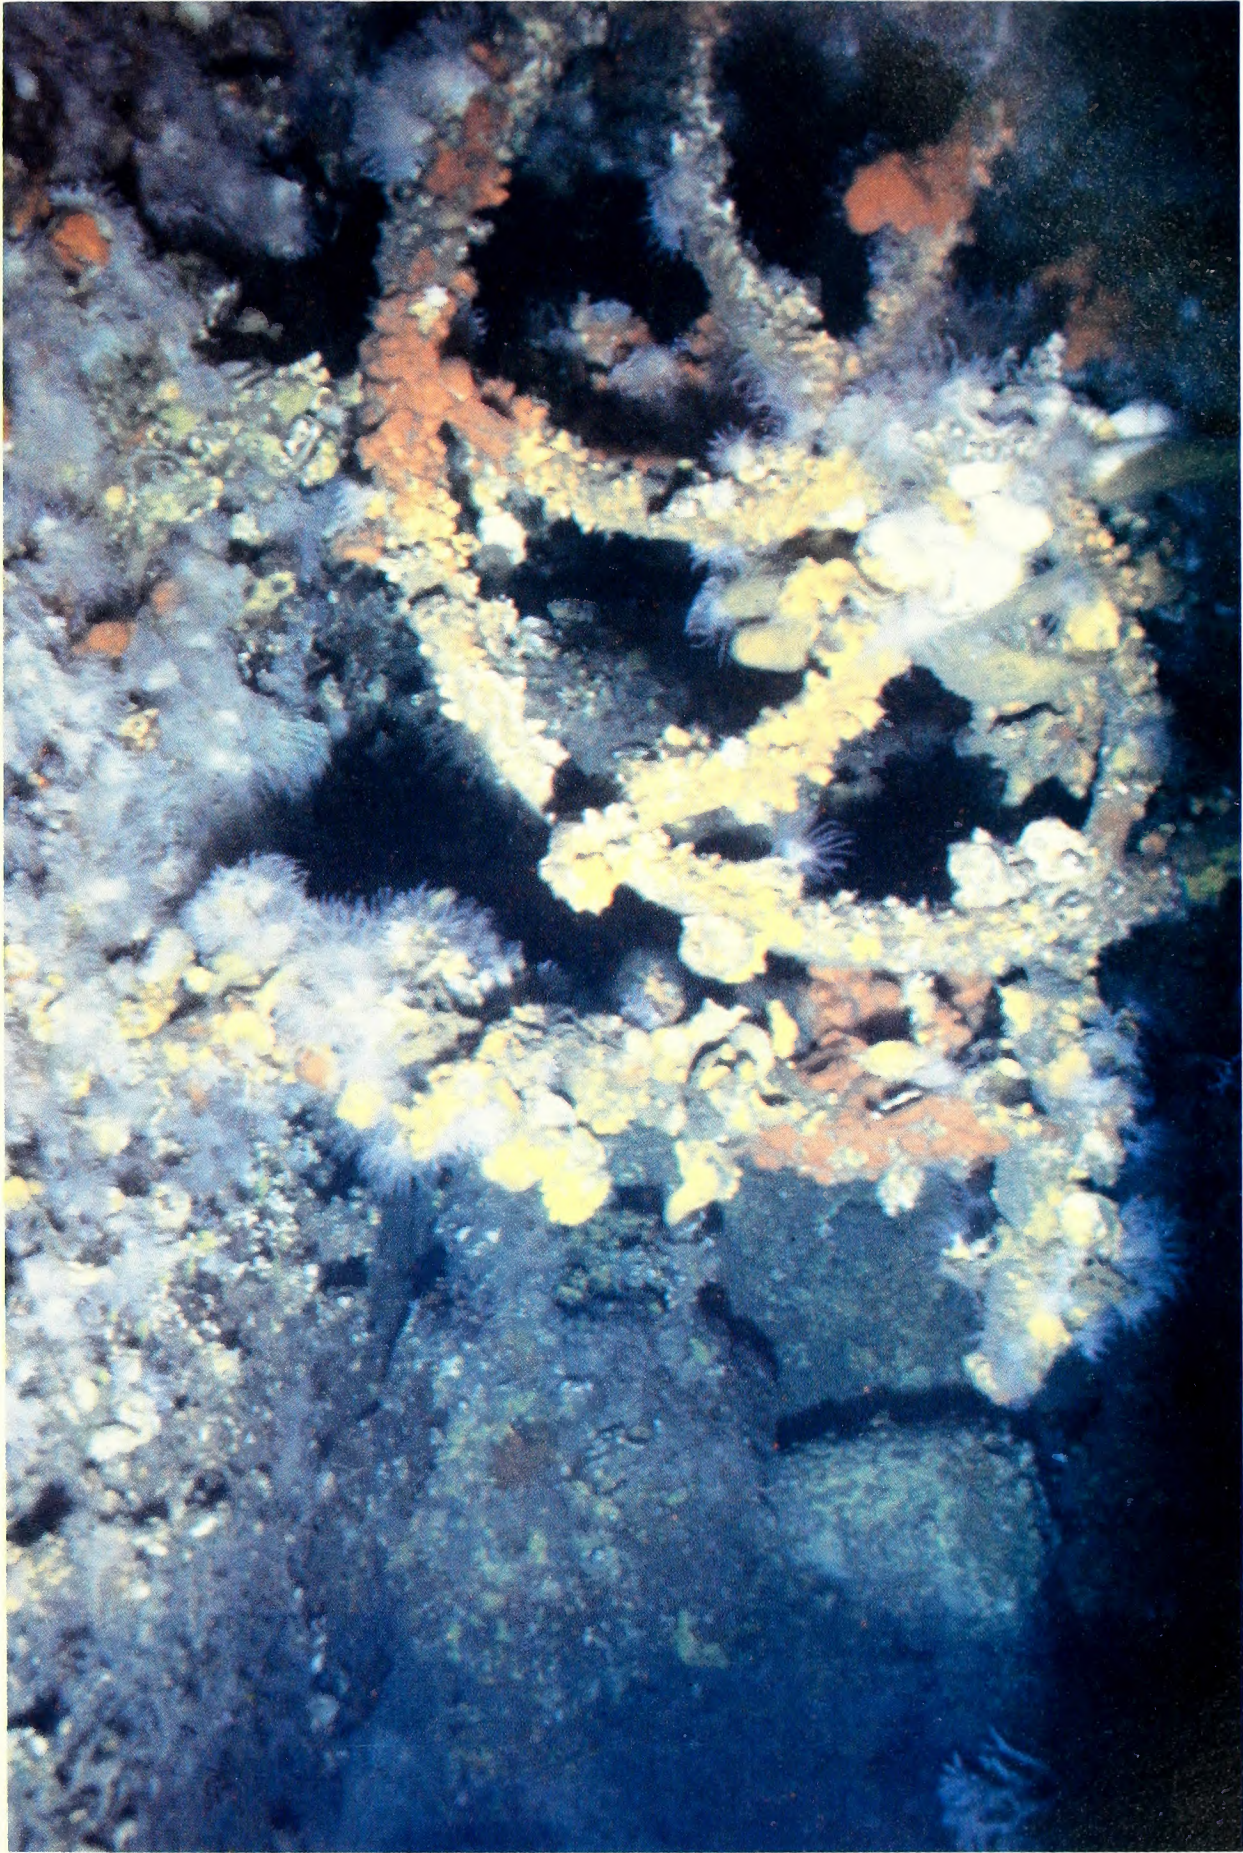
Figure 124. Amidships and forward of the engine support platform a serpentine-spoked wheel that activated a valve chest for reversing the engine remains attached to a strut protruding from the engine room bilge ceiling. To the left and aft of the wheel, the air chamber and steam cylinder for the port Worthington pump can be seen.

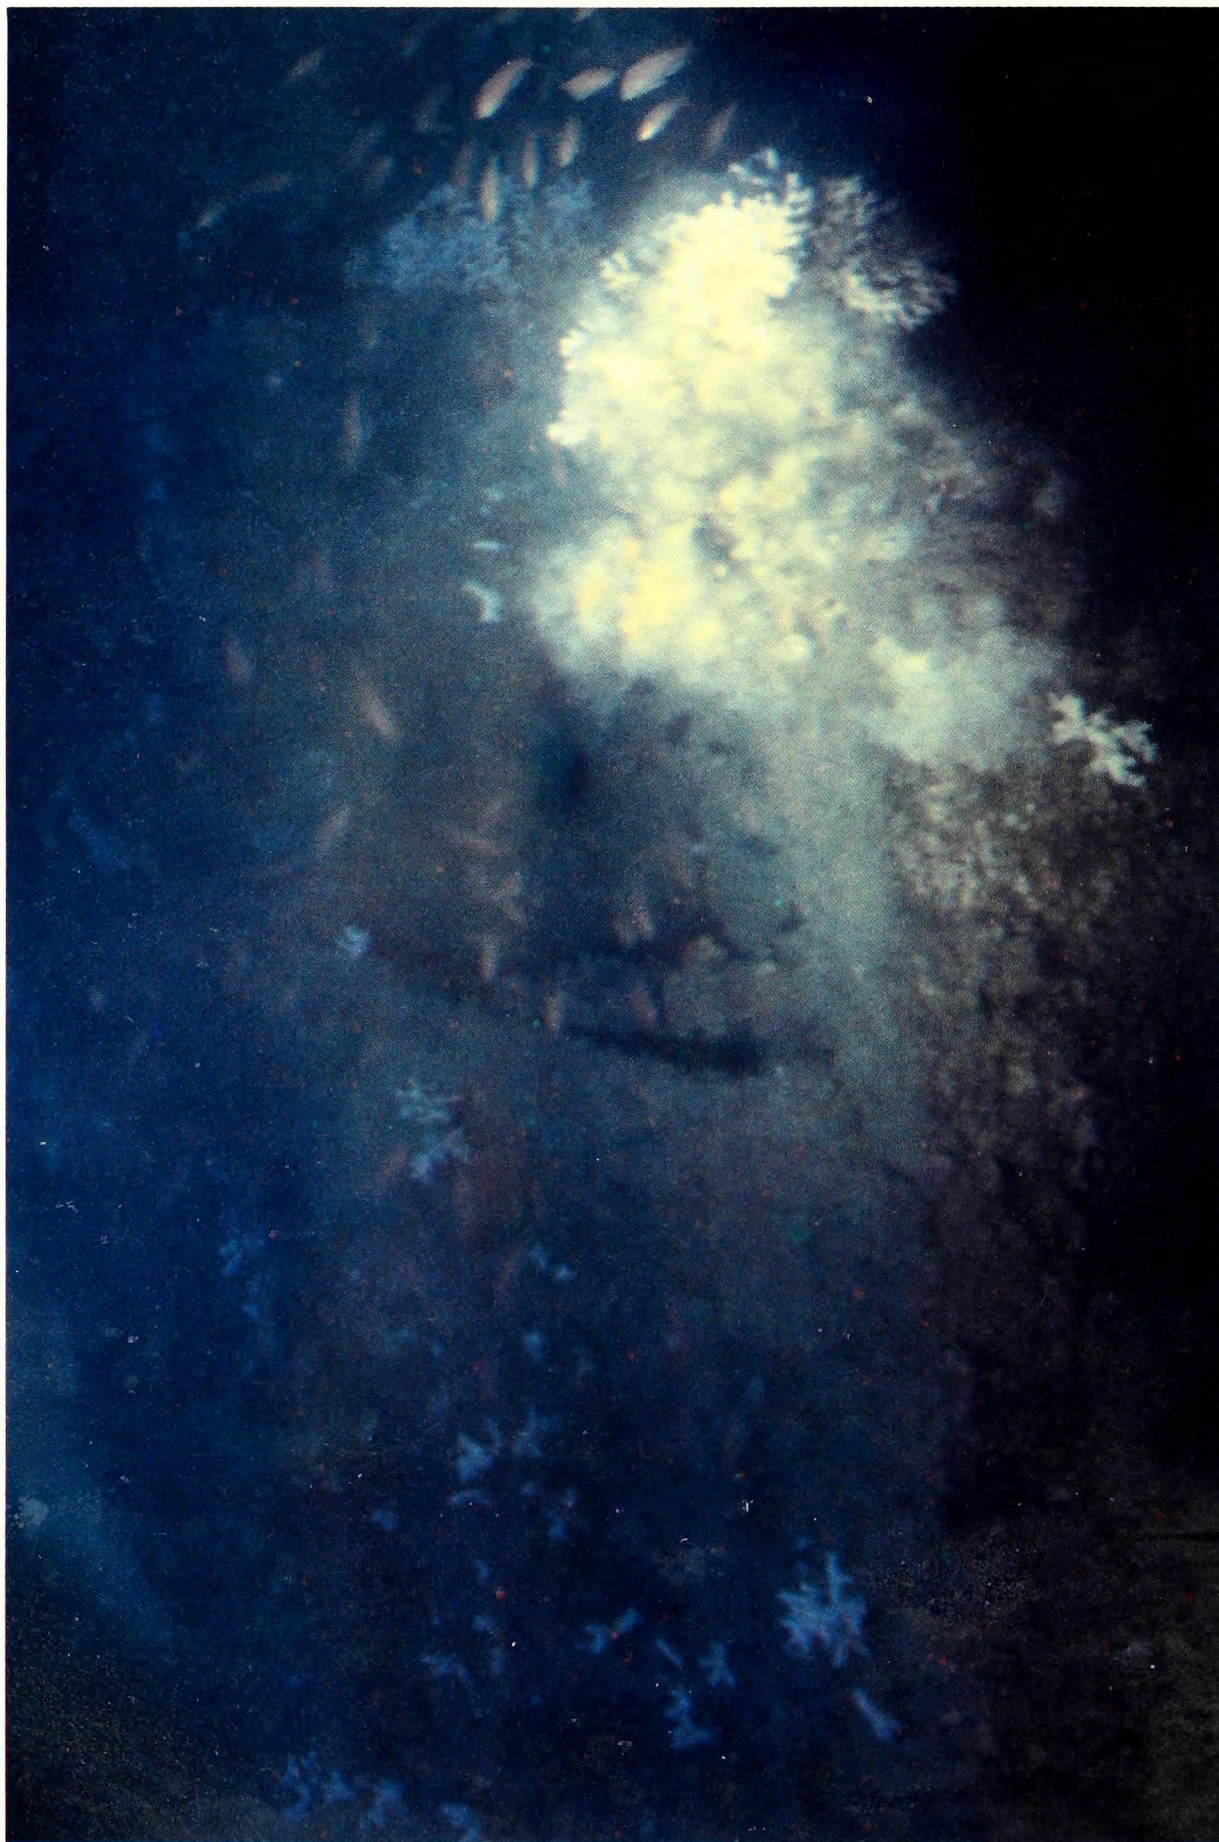
Figure 127. At the stern, the starboard armor belt exhibits extensive damage and most interior wood has deteriorated.

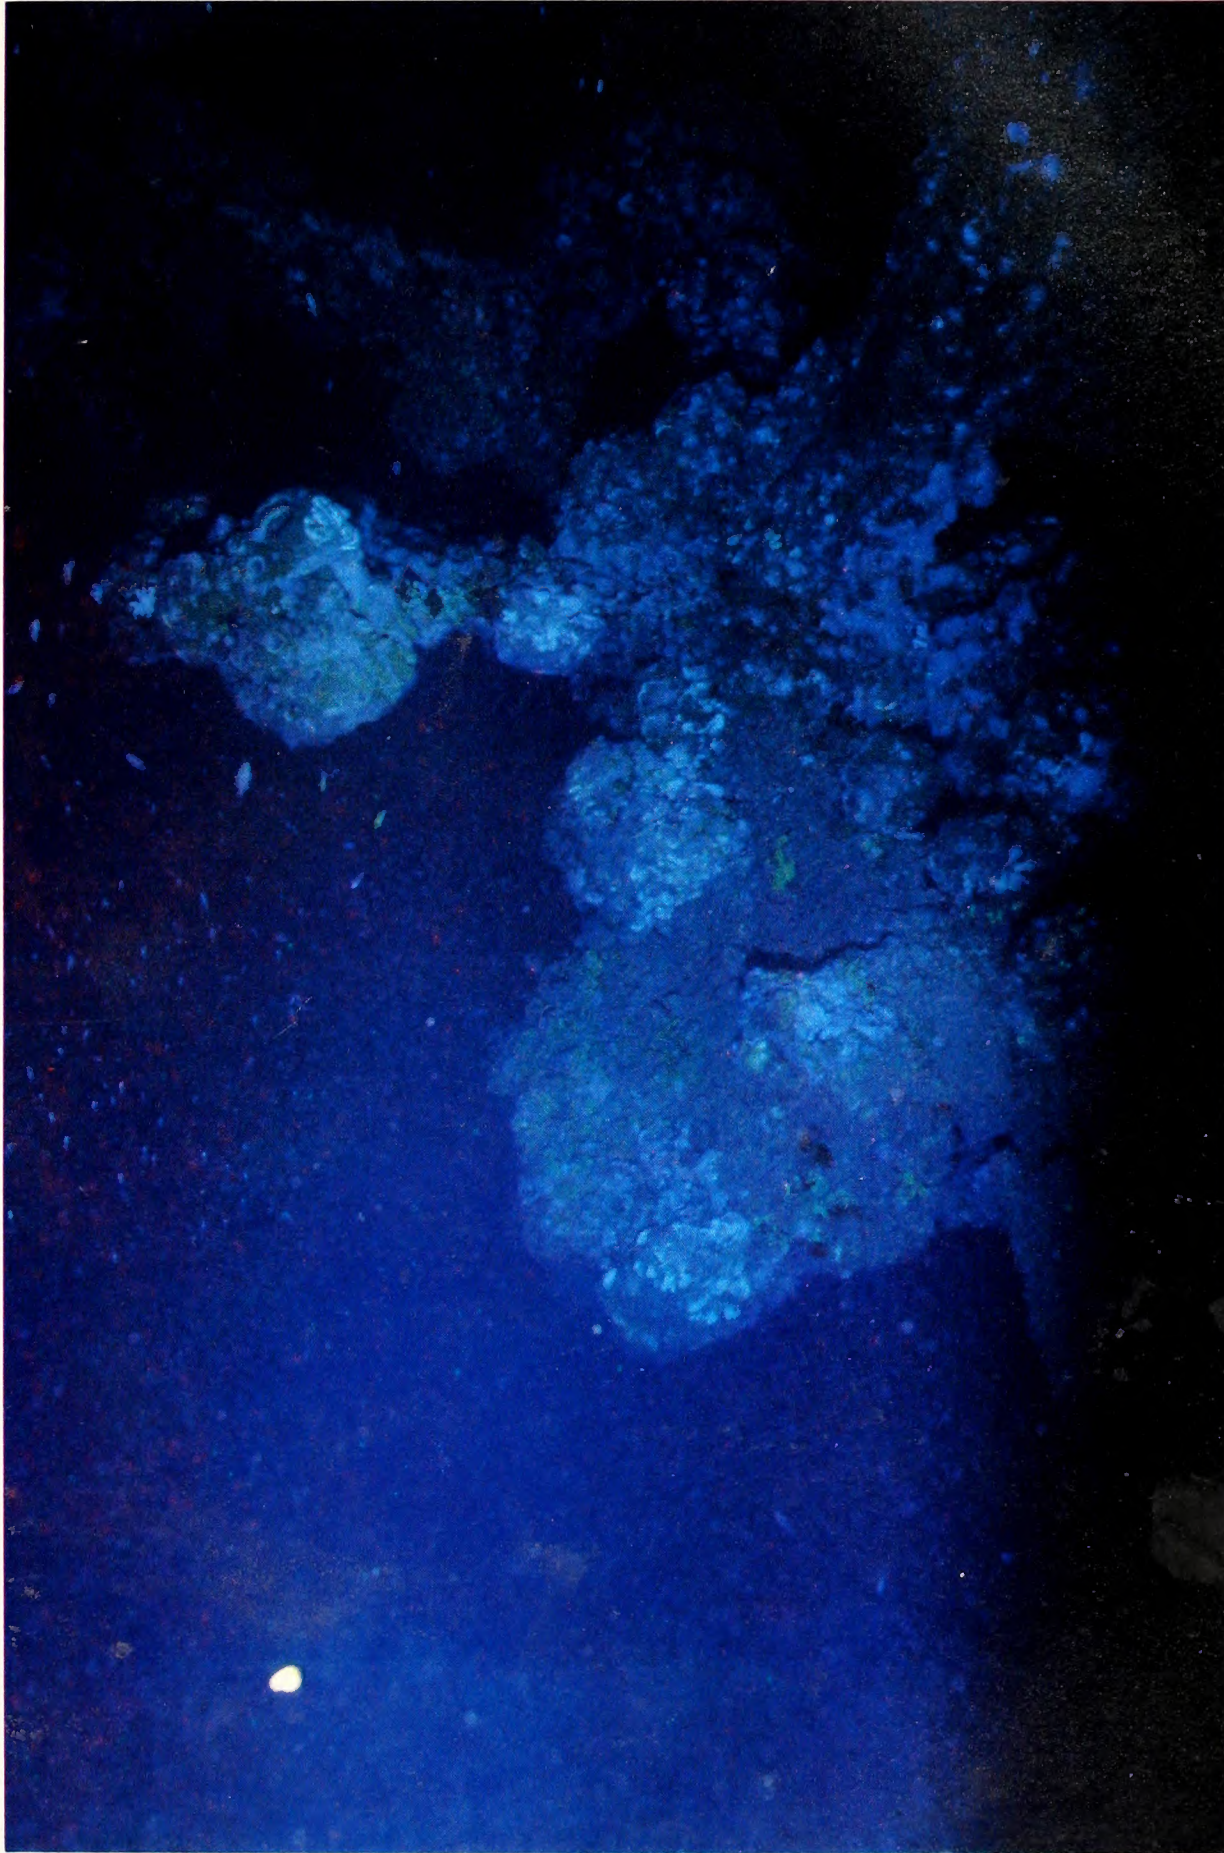
Figure 128. Photographed from the port armor belt, the four blades of Ericsson's propeller can be clearly seen. The propeller shaft extends into the photograph from the lower left corner and the yoke and propeller shaft socket appear behind the propeller and to the right. The propeller shaft no longer rests in the yoke socket and lies to the port of the yoke.

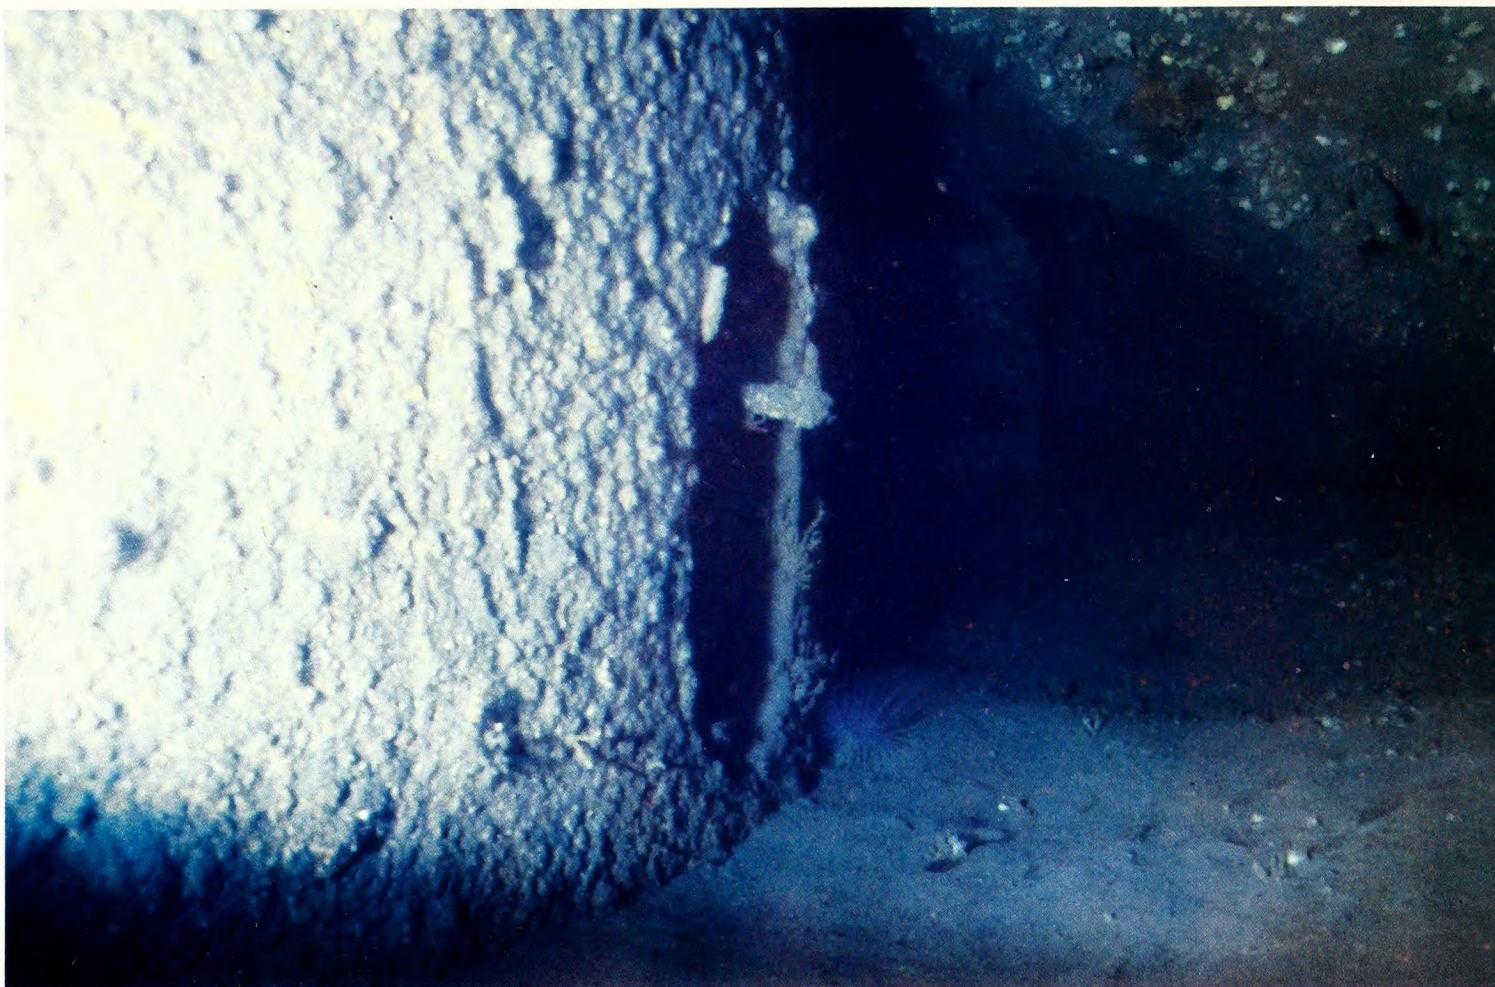
Figure 129. Beyond the turret, armor plates from the damaged after-deck of the Monitor were found to have separated from their fastenings and collapsed onto the sediment. Shafts protruding from the gun ports (starboard top and port bottom) were used to secure wood gun port bucklers (covers) to heavy wrought iron pendulums inside the turret while the ship was underway.

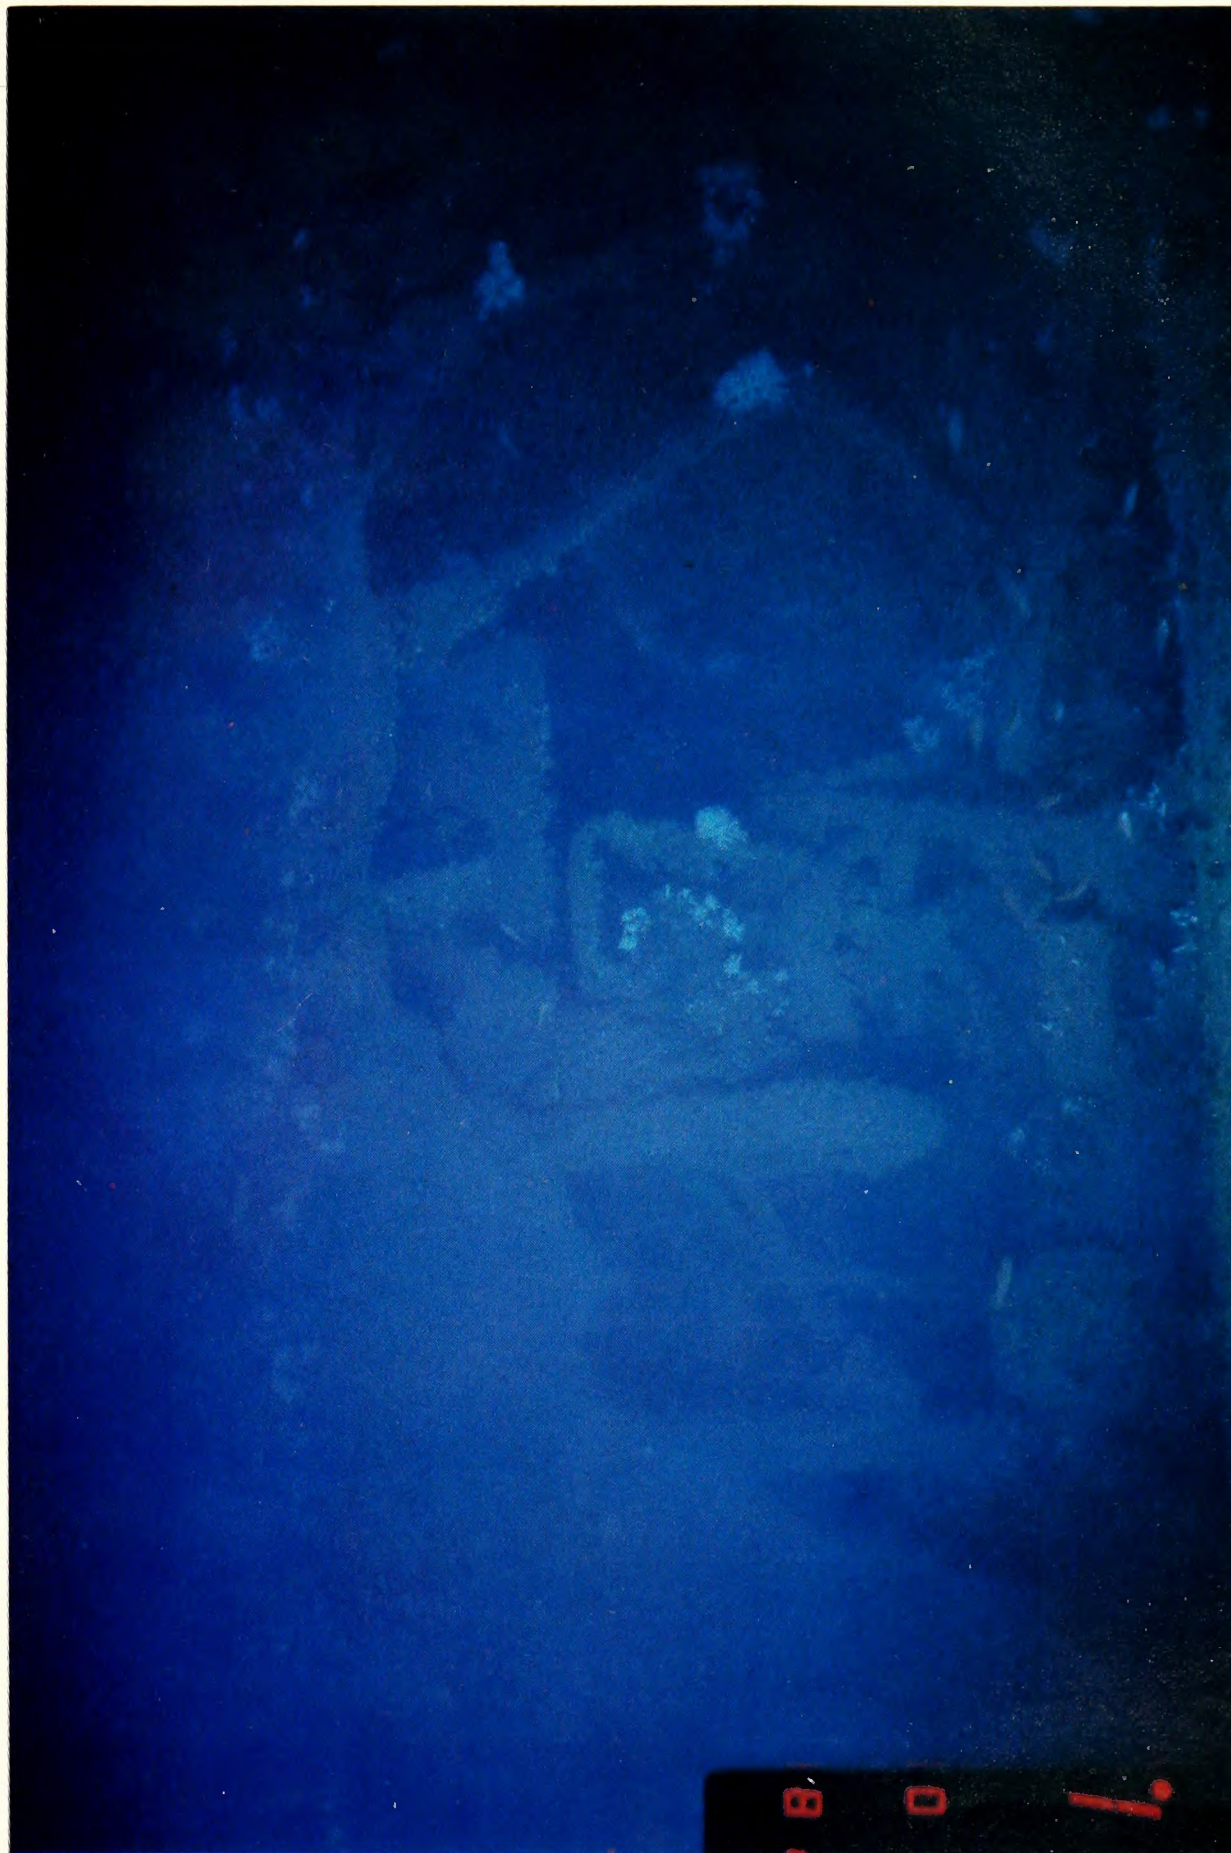
Figure 133. Damage to the lower hull along the port quarter permitted access to the engineering space of the Monitor. Debris and heavy fouling obscure all but a serpentine-spoked wheel on one of the two blowers that were used to create a forced draft for the boilers. Once-straight wrought iron stanchions (to the right of center) preserve evidence of either the dynamics of sinking or perhaps damage resulting from depth charges during World War II.

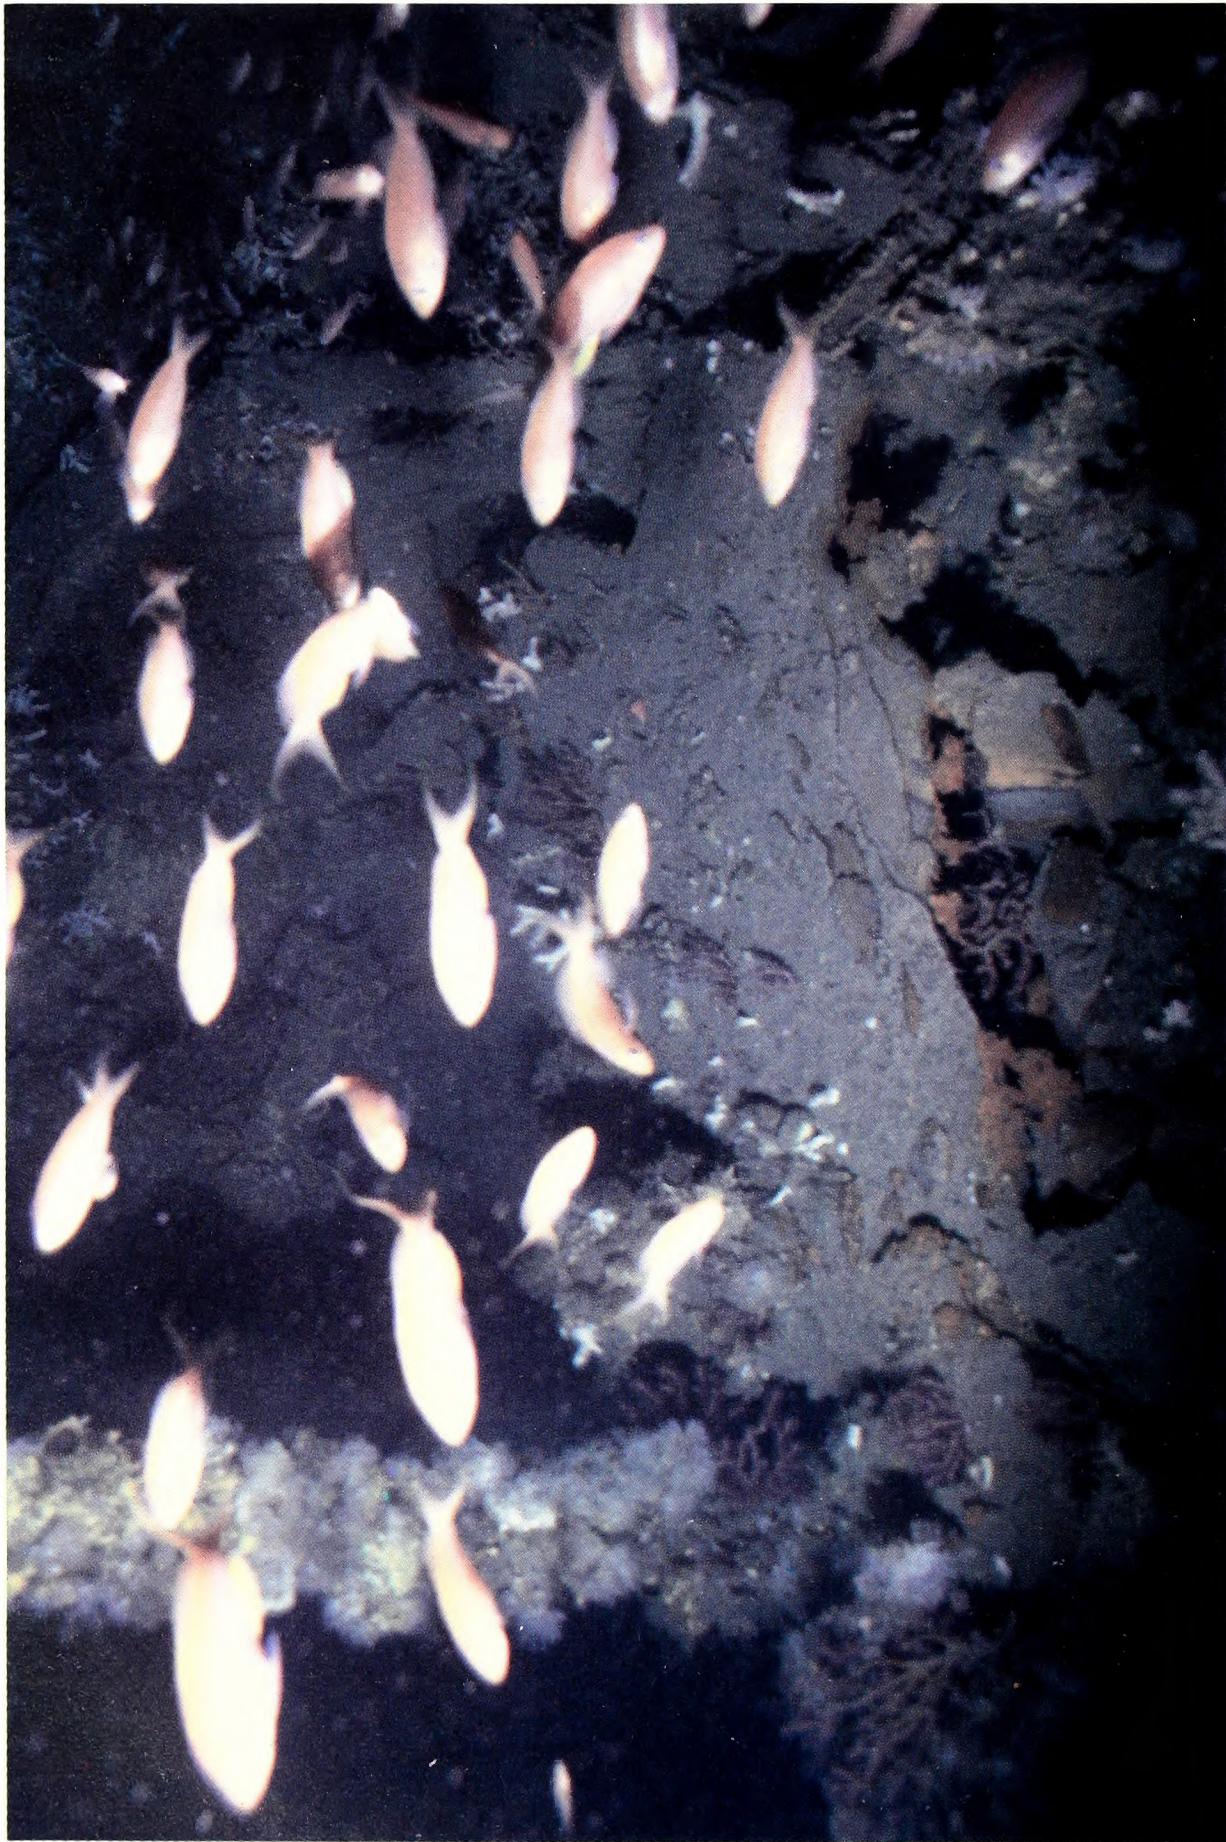
Figure 134. The fragile condition of much of the remains of the Monitor can easily be seen in the remains of an iron hull plate damaged in investigating the interior of the Monitor's engineering space aft of the amidships bulkhead.

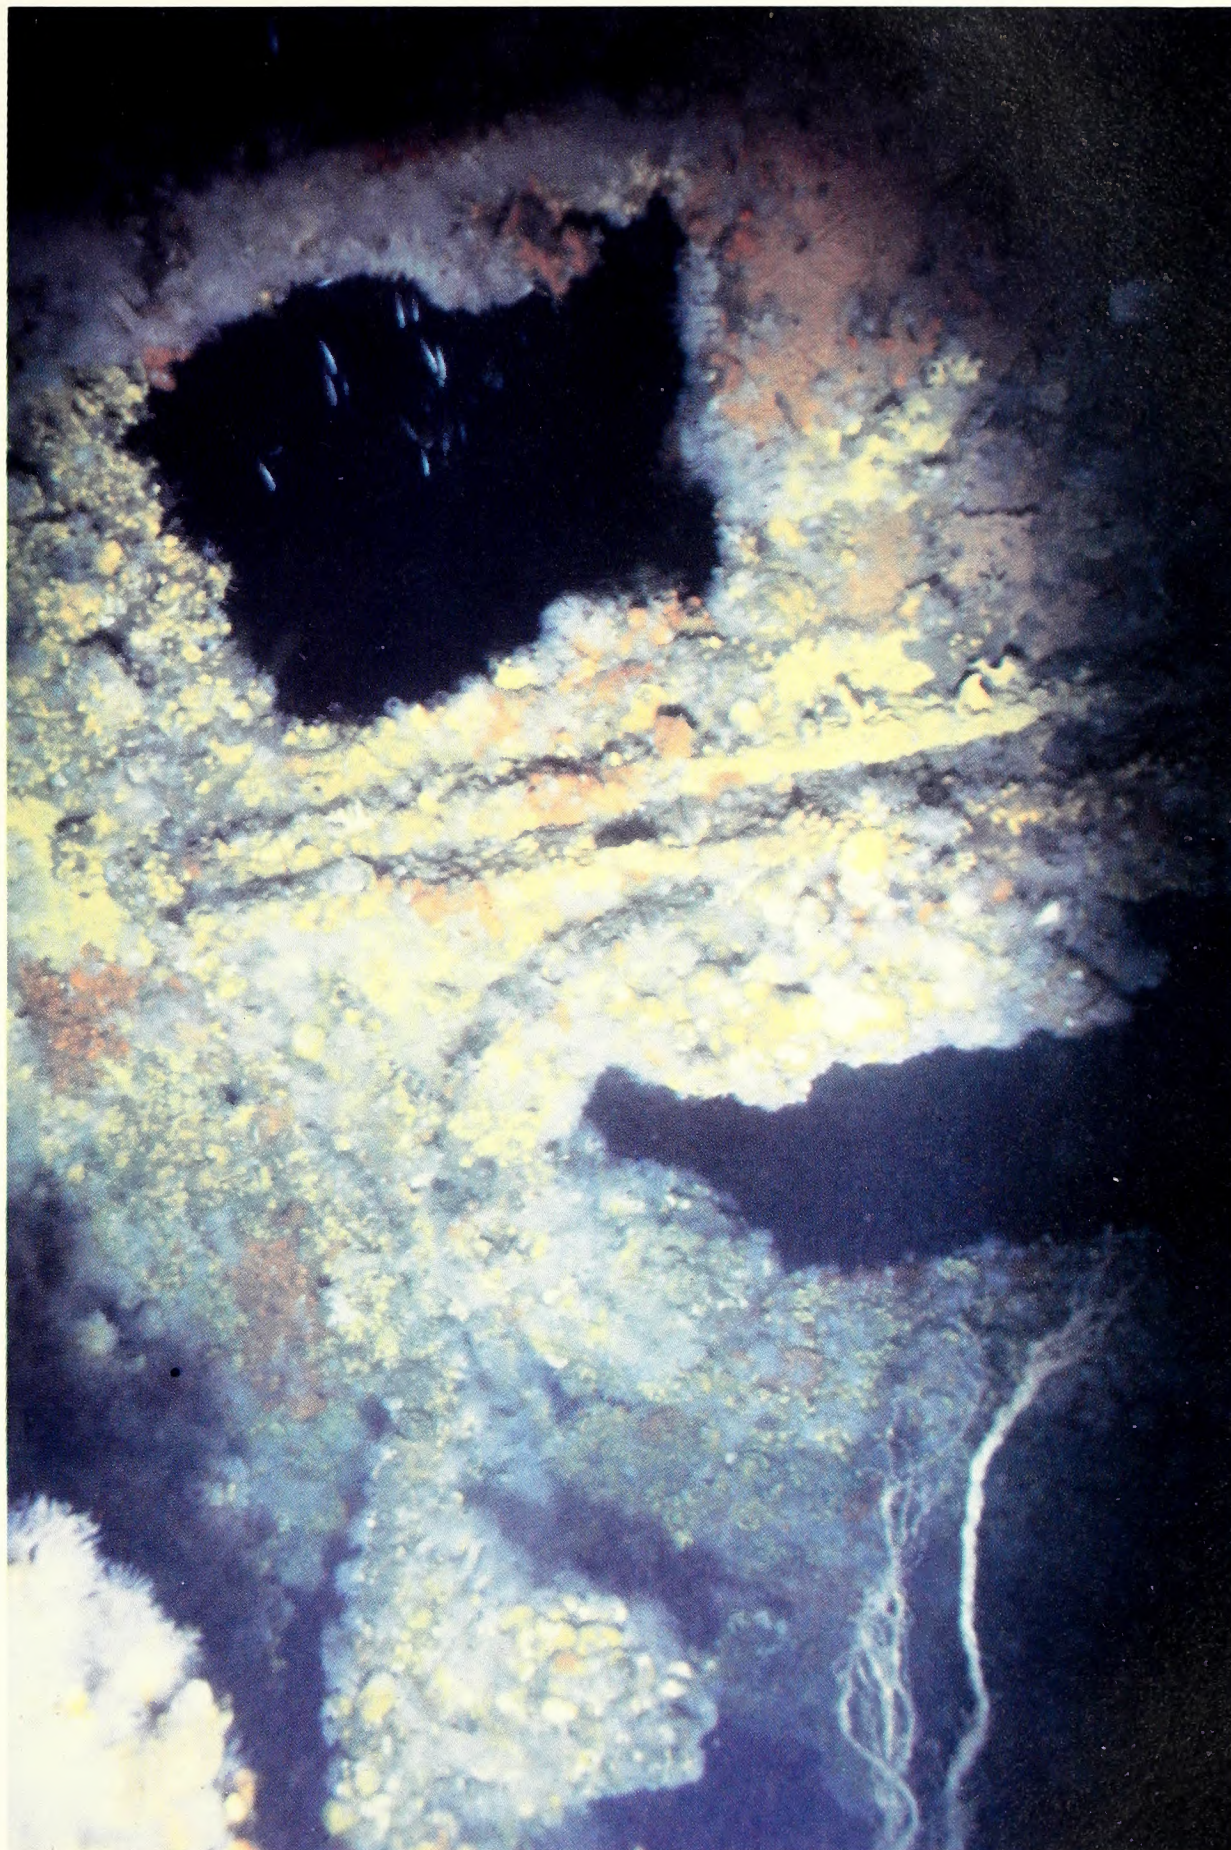
Figure 135. The starboard watertight door frame in the amidships bulkhead survives intact although plate on the bulkhead has deteriorated. To port of the turret support yoke the bulkhead has collapsed into the galley.

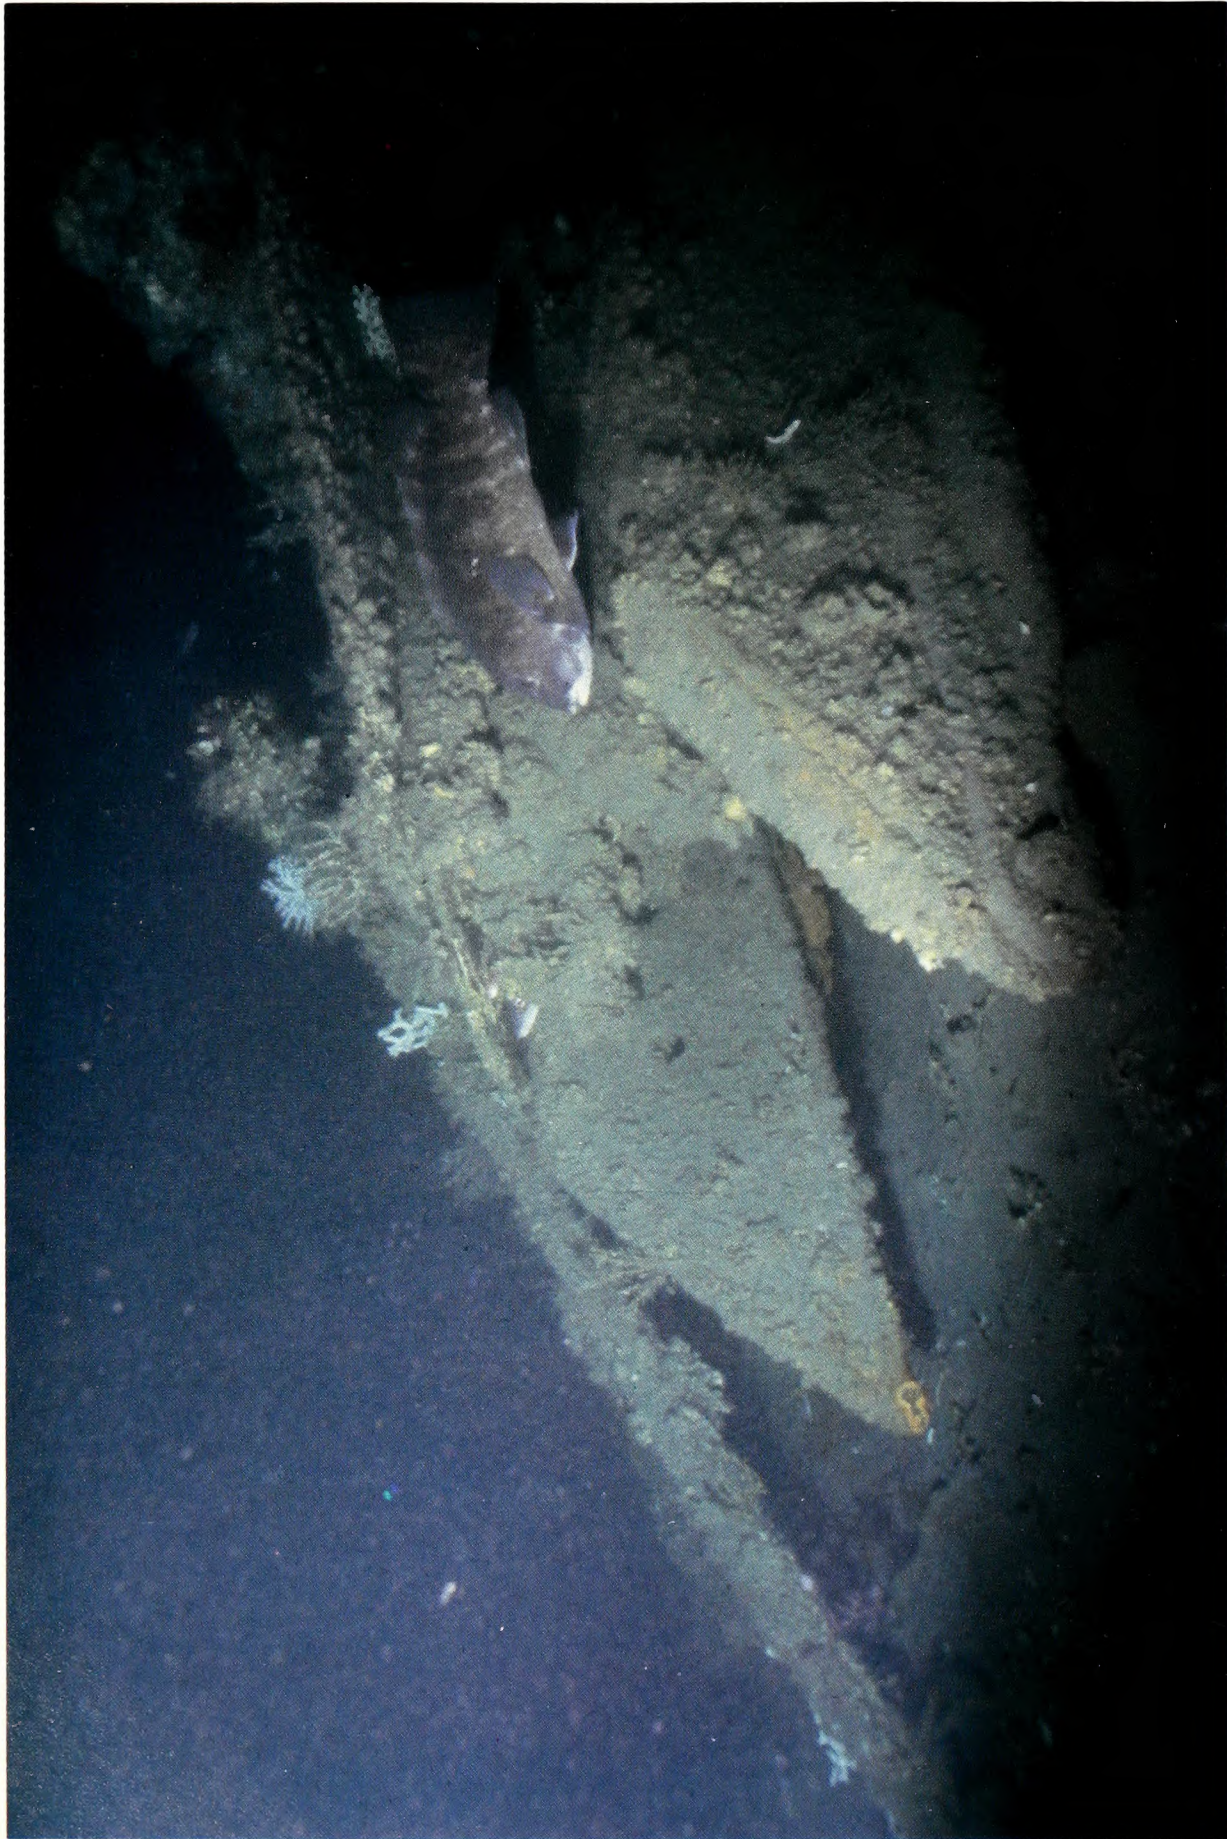
Figure 136. Iron floors and stiffeners constructed of iron plate and angle preserve both the contours and construction features of the lower displacement hull of the Monitor.
